# First Shield Home Inspections

**456 Insurance Inspection BLVD, Los Angeles, CA, 90066**

Insurance

4 System Inspection

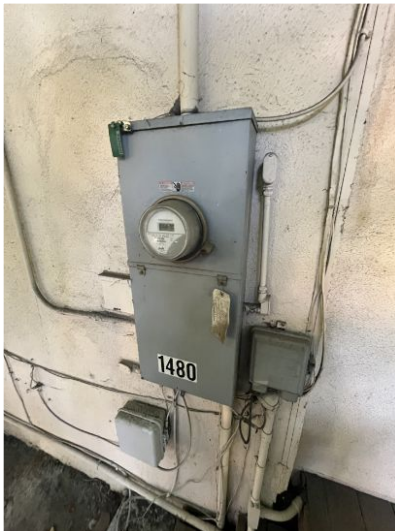
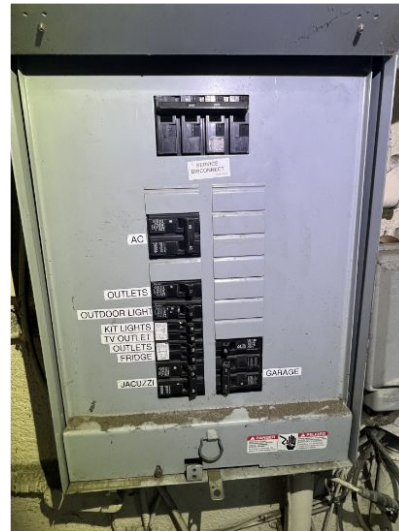
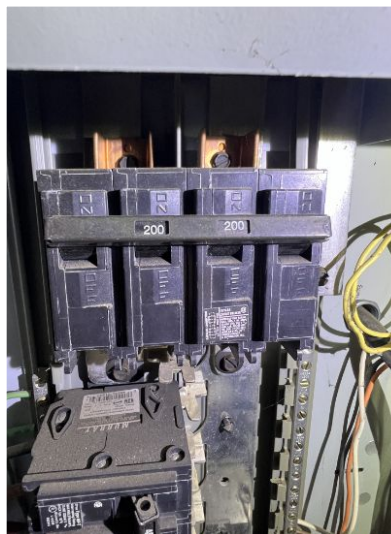
The estimated age of this panel is: 18 years old.

The electrical system is in: Good condition.

There is 200 amps for this building from the main panel.

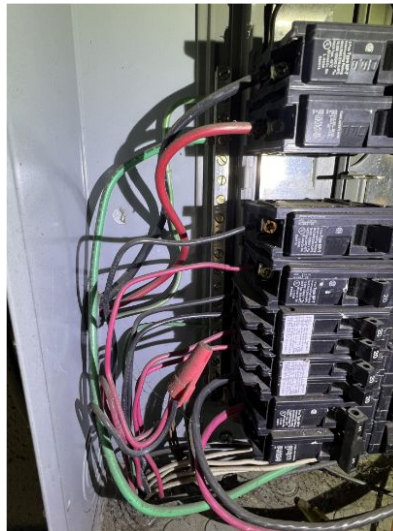
The wiring in the building is made of copper.

The wiring is sheathed in a plastic coating. This is the current standard covering for electrical wiring.

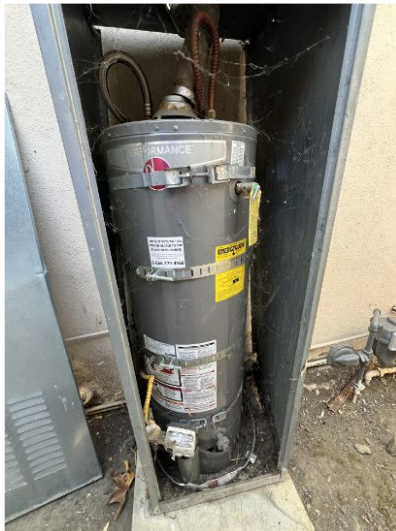
WATER HEATER 1 (Outside)

This water heater is: 3 years old.

The water heater is in: Good condition.

Water Heater 1 - the temperature/pressure relief valve has no drain line installed to take the water away to a safe location if the valve releases. We recommend this drain line be installed in case this valve ever releases.

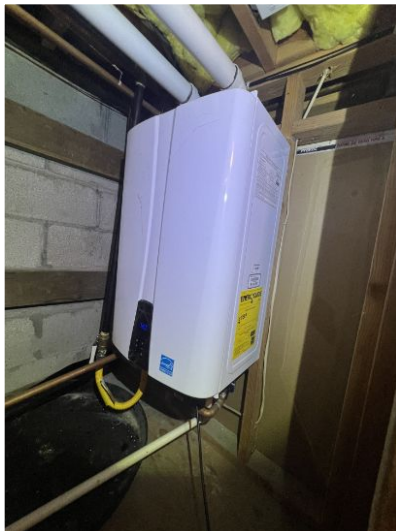
Water Heater 2

WATER HEATER 2 (Garage)

This water heater is: 6 years old.

The water heater is in: Good condition.

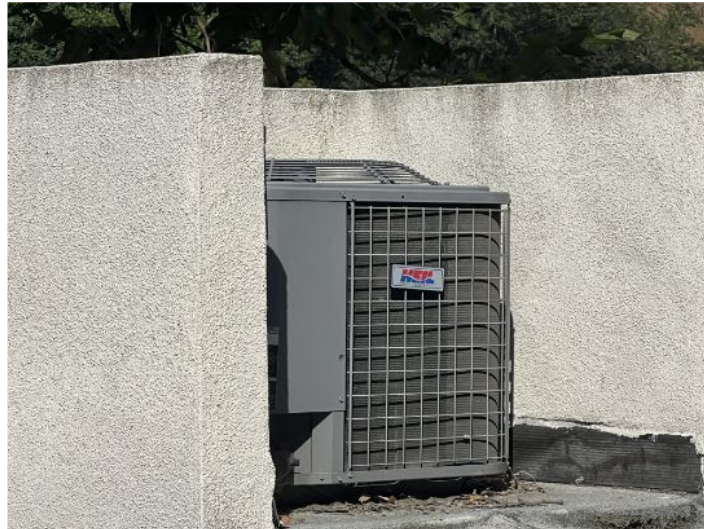
HVAC 2 - condenser

There are multiple colling units in use on this property.  
 Unit 1- the unit is 11 years years old.  
 Unit 2- the condensers is 18 years old.

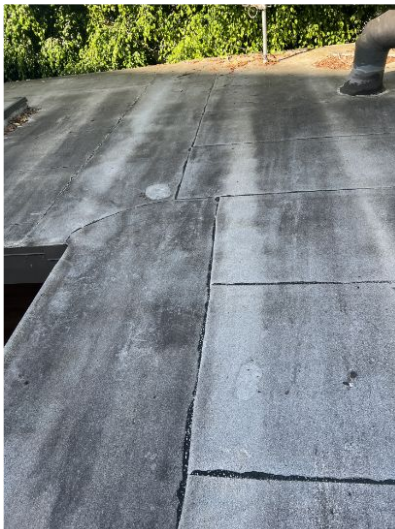
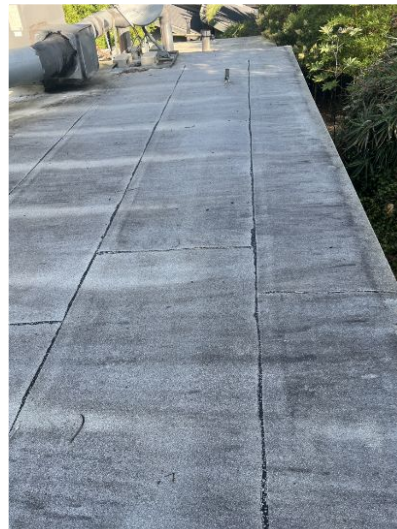
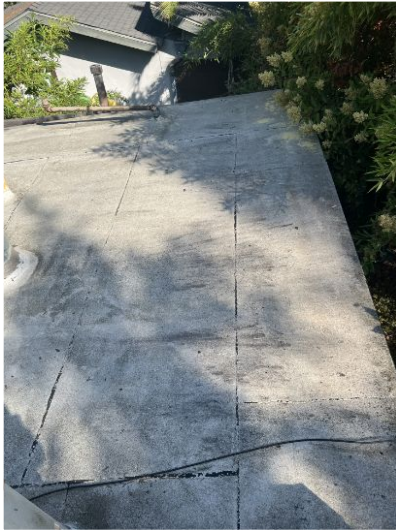
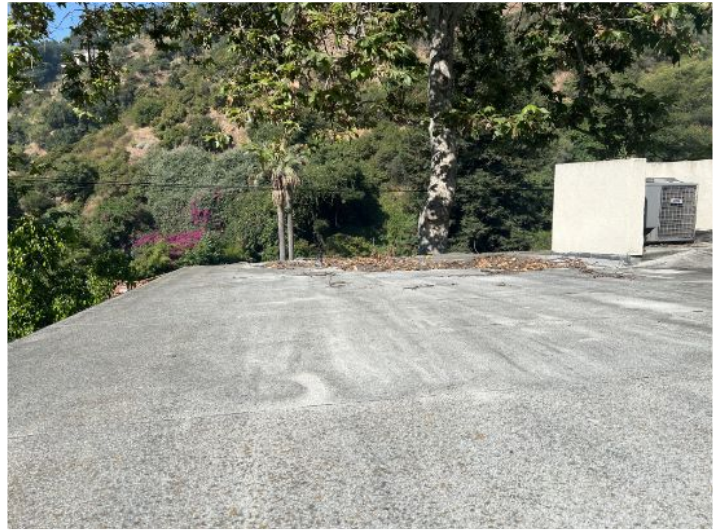
The age of this roof is approximately 20 - 30 years old.

The roof system is in: Fair condition.

The roof is a flat roof with a low pitch - commonly referred to as a low sloped roof

The roof surface contains rolled composition roofing, (BUR) built-up roofing, or cap sheet.
