# First Shield Home Inspections

**123 Insurance Inspection Way, Los Angeles, CA, 90066**

**Date of Inspection: 8/26/2024**

**4 System Inspection**

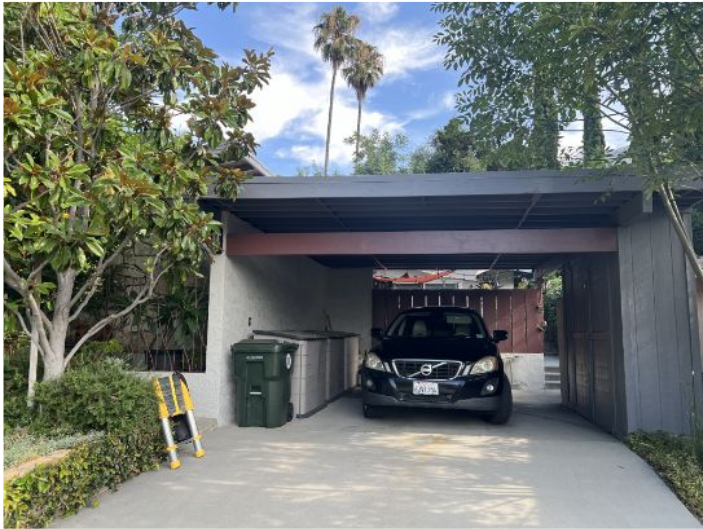
Front / Garage

A visual inspection of the exterior wall covering condition found it to be in a serviceable condition at time the of inspection.

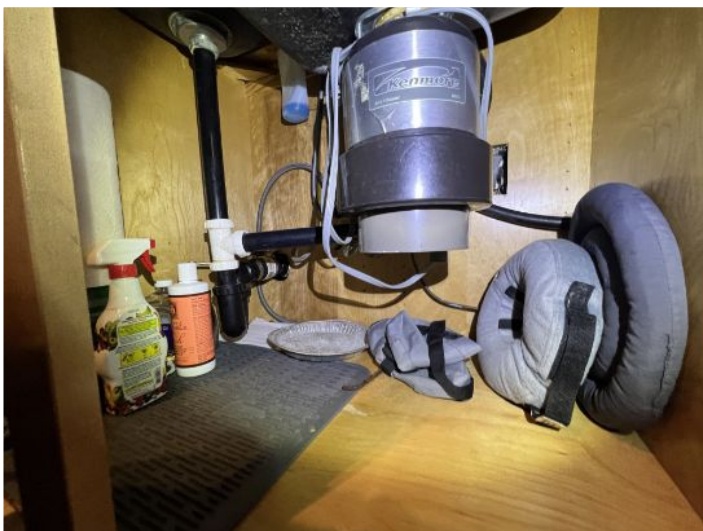
Under kitchen sink

The interior piping that supplies the water throughout the building is made of copper where visible.

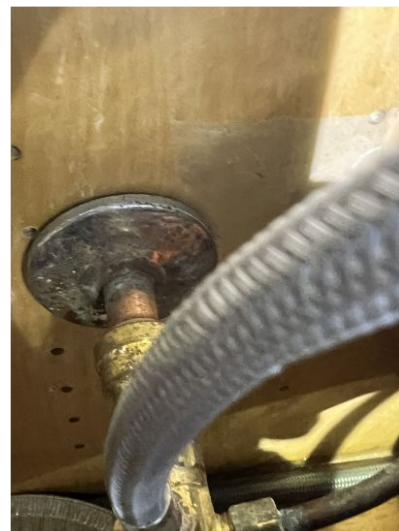
Kitchen - Copper

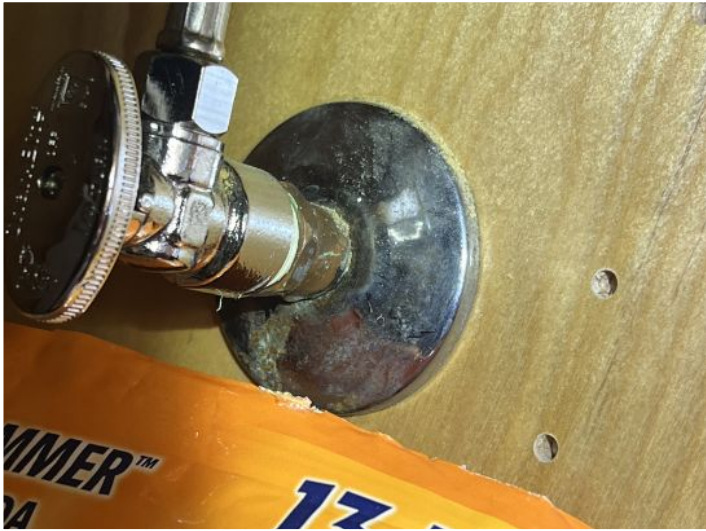
Bathroom 1 - copper

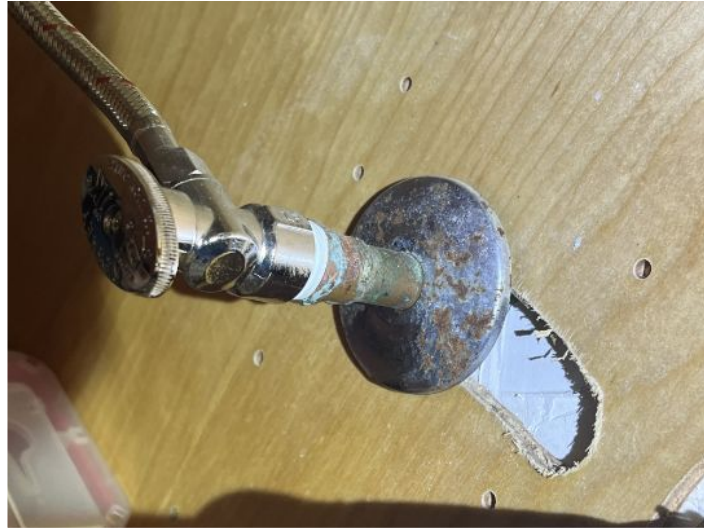
Under bathroom 2 - copper

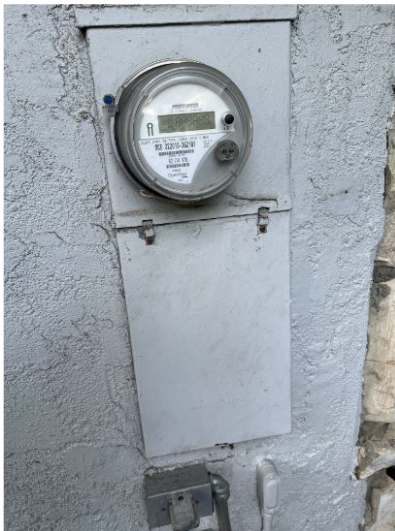
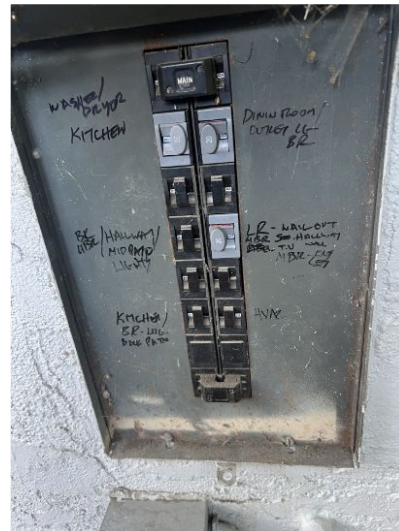
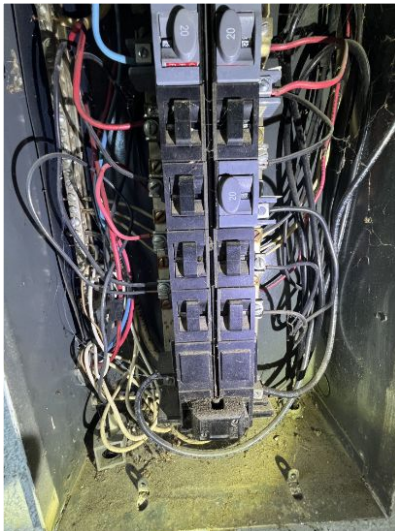
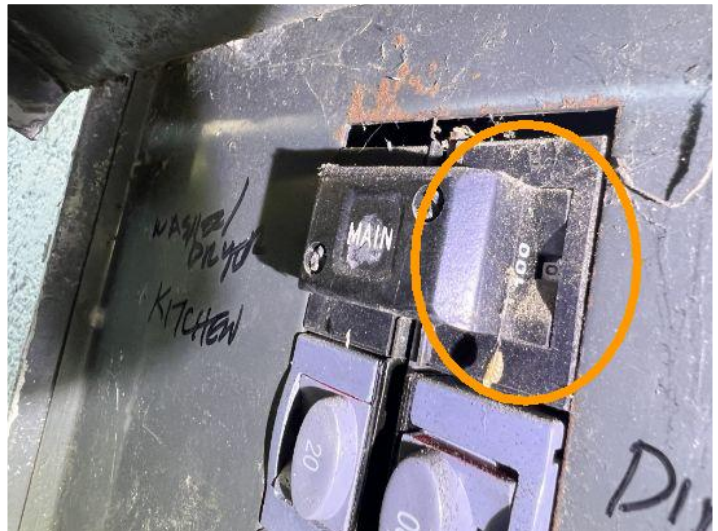
The estimated age of this panel is: 40 - 50 years old.

There is 100 amps for this building from the main panel.

This is an older main electric panel.

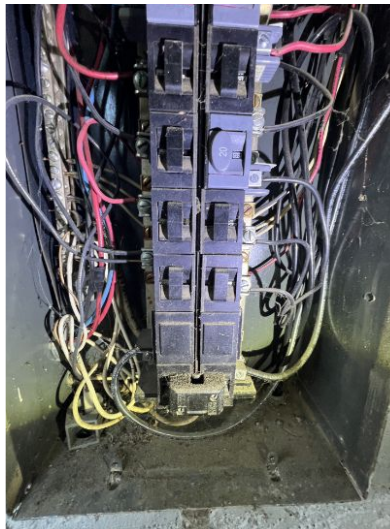
The wiring in the building is made of copper. - There appears to have been upgrades to the wiring. The approximate age of the wiring is 10-15 years.

The wiring is sheathed in a plastic coating. This is the current standard covering for electrical wiring.

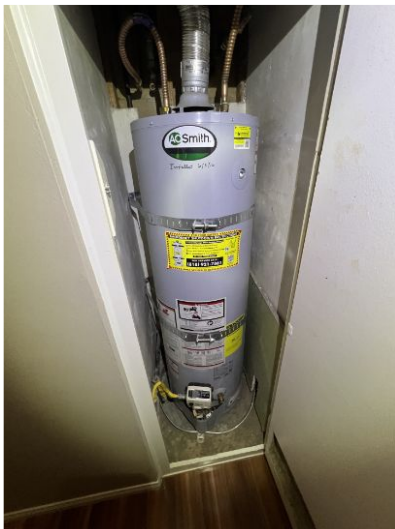
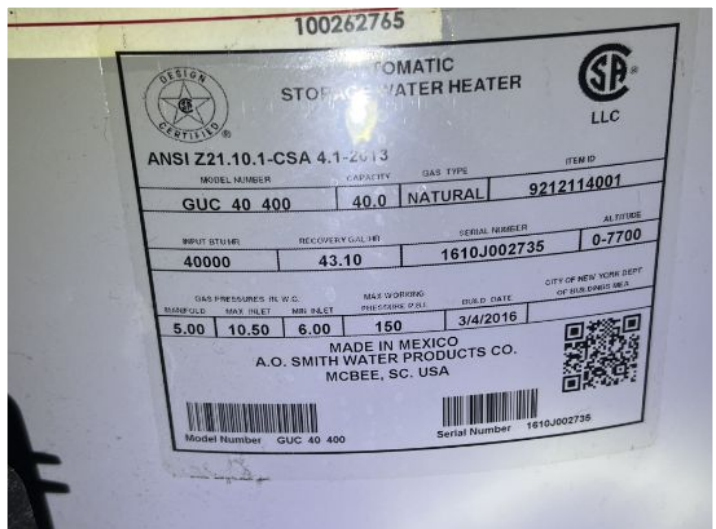
This water heater is: 8 years old.

The water heater is in: Excellent condition.

Manufactured 2016 / 40 gallon

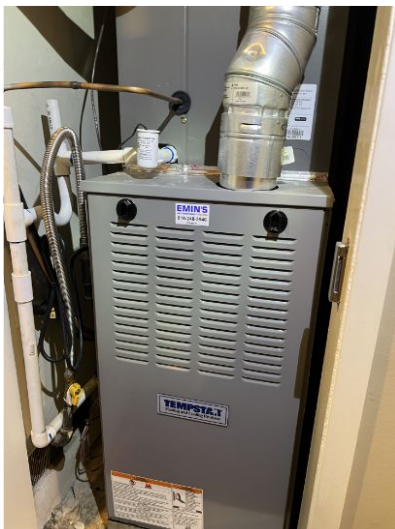
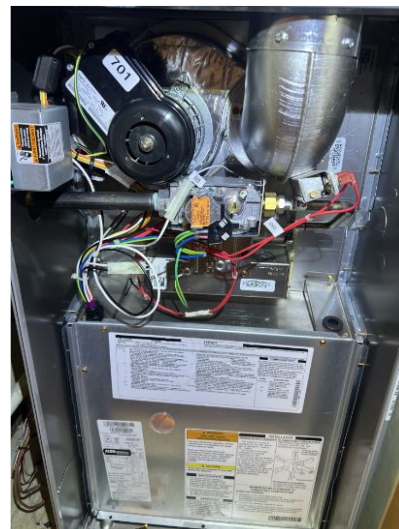
The furnace is 2 years old.

The HVAC system is in: Excellent condition.

The system is installed in a closet in the hallway.

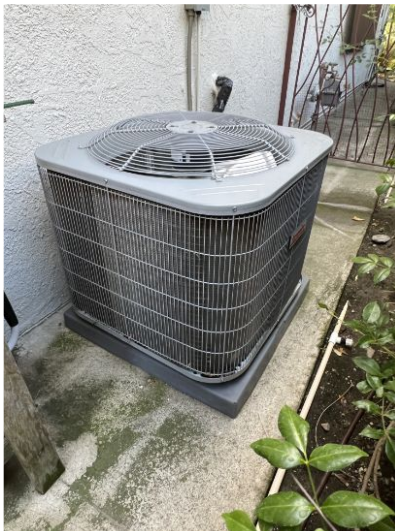
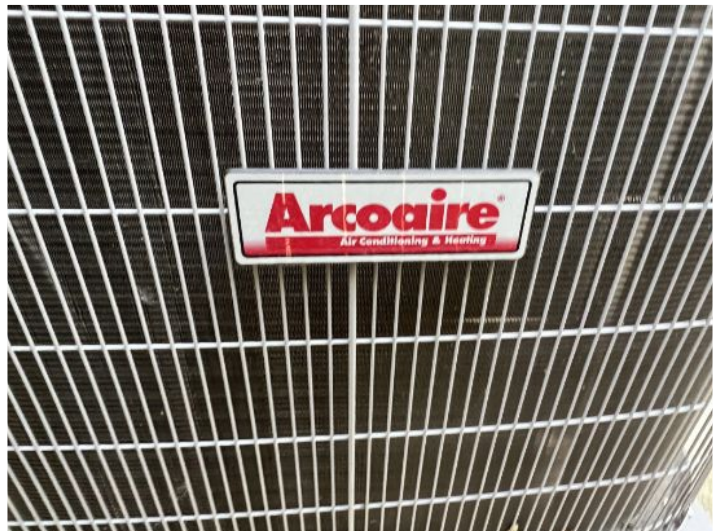
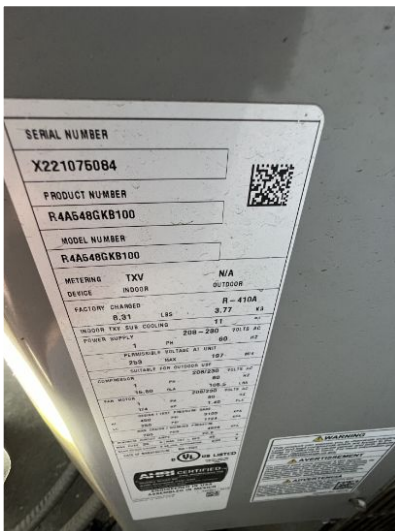
The condenser is 2 years old.

The condenser is in: Excellent condition.

Manufactured 2022

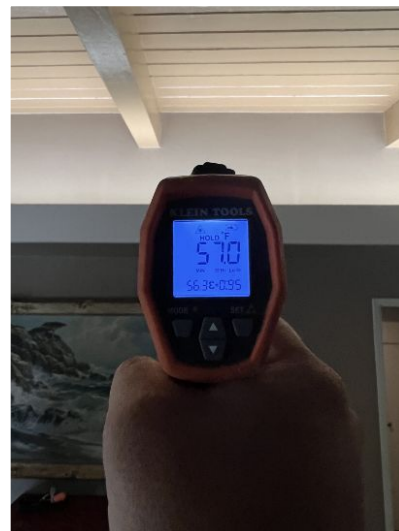
51 deg F

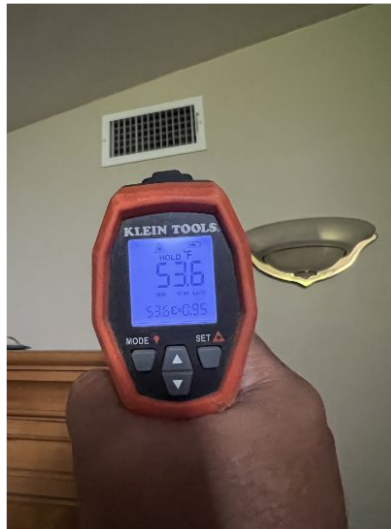
53 deg F

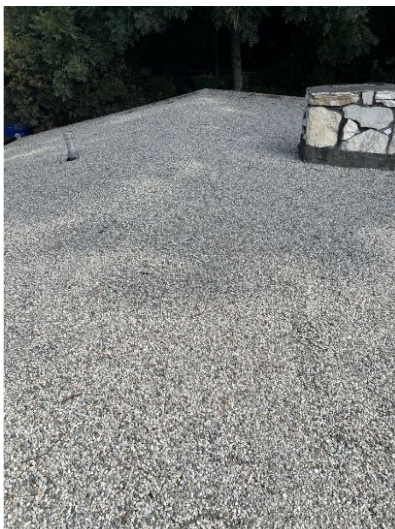
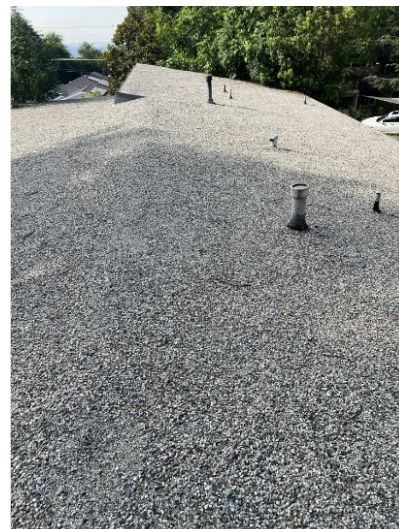
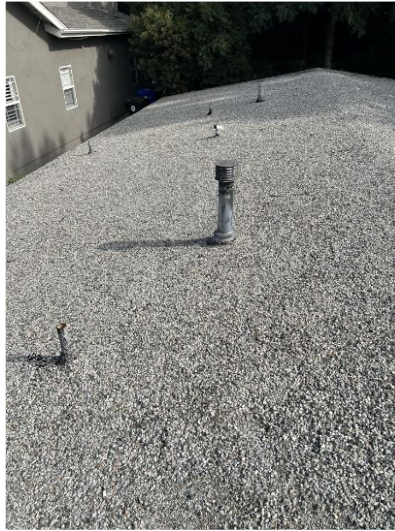
The age of this roof is approximately 10 - 15 years old.

The roof system is in: Good condition.

The roof surface contains built up layers of roofing paper with tar and gravel on top of it.
